PERATION

GREENHOUSE

SCIENTIFIC DIRECTOR'S REPORT

ANNEX 3.2 U. S. NAVY STRUCTURES

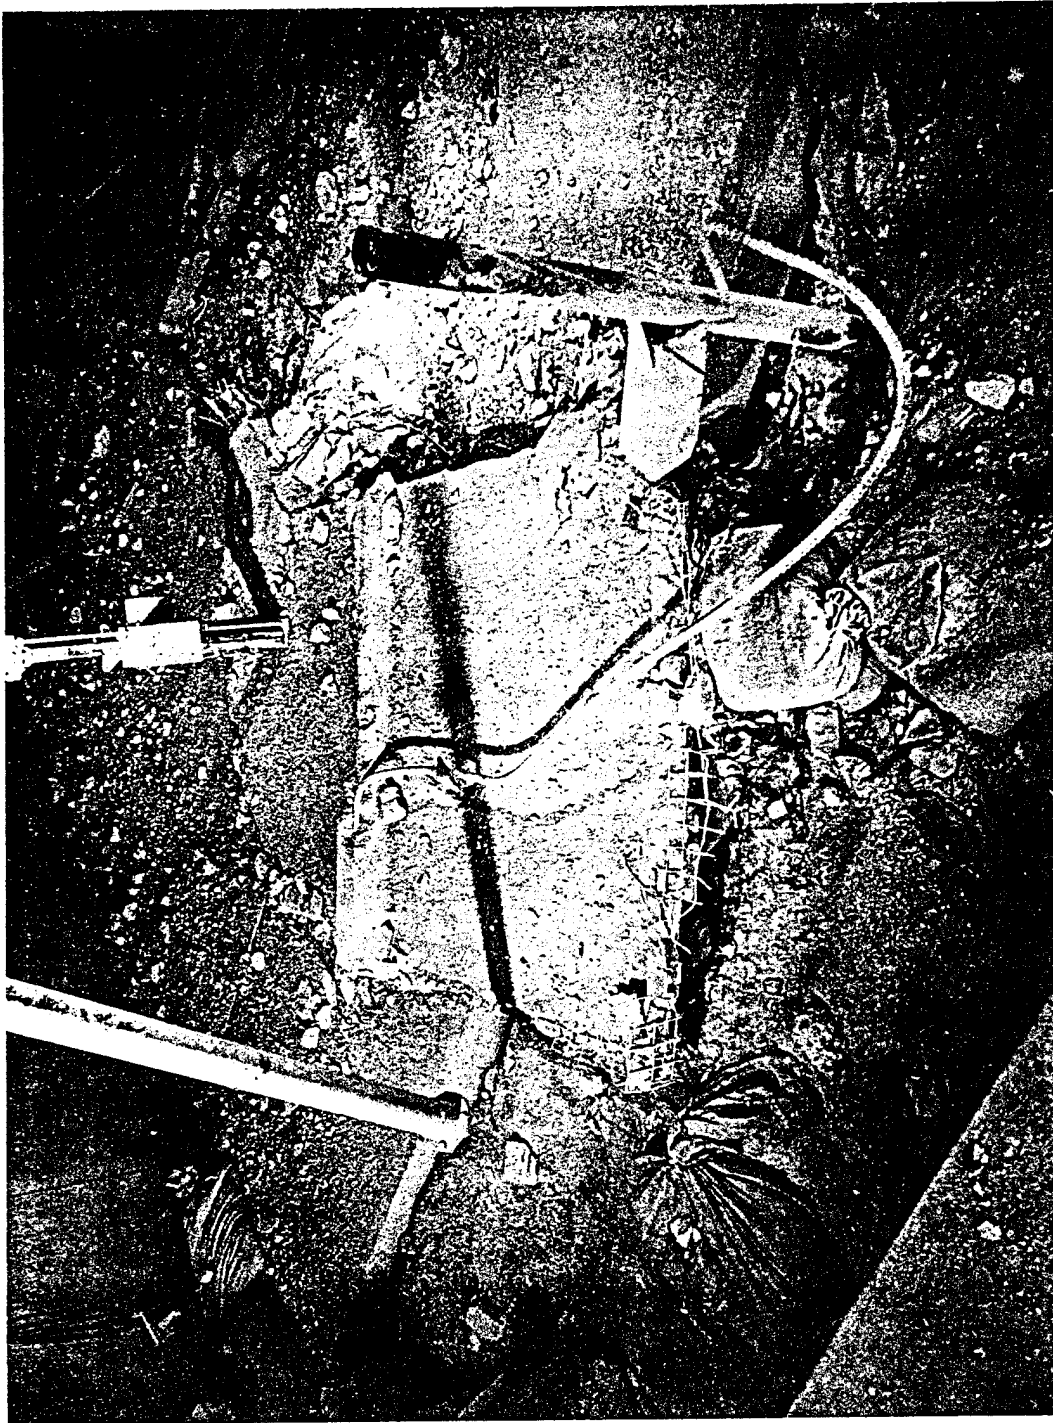
Fig. L. 314 Interior View, Looking toward Left End Wall, Structure 3.2.4a. Most of the displacement gauge rods were struck with debris. Note the section of a panel lying across the floor just past the opening in the floor. See next photograph for detail view.

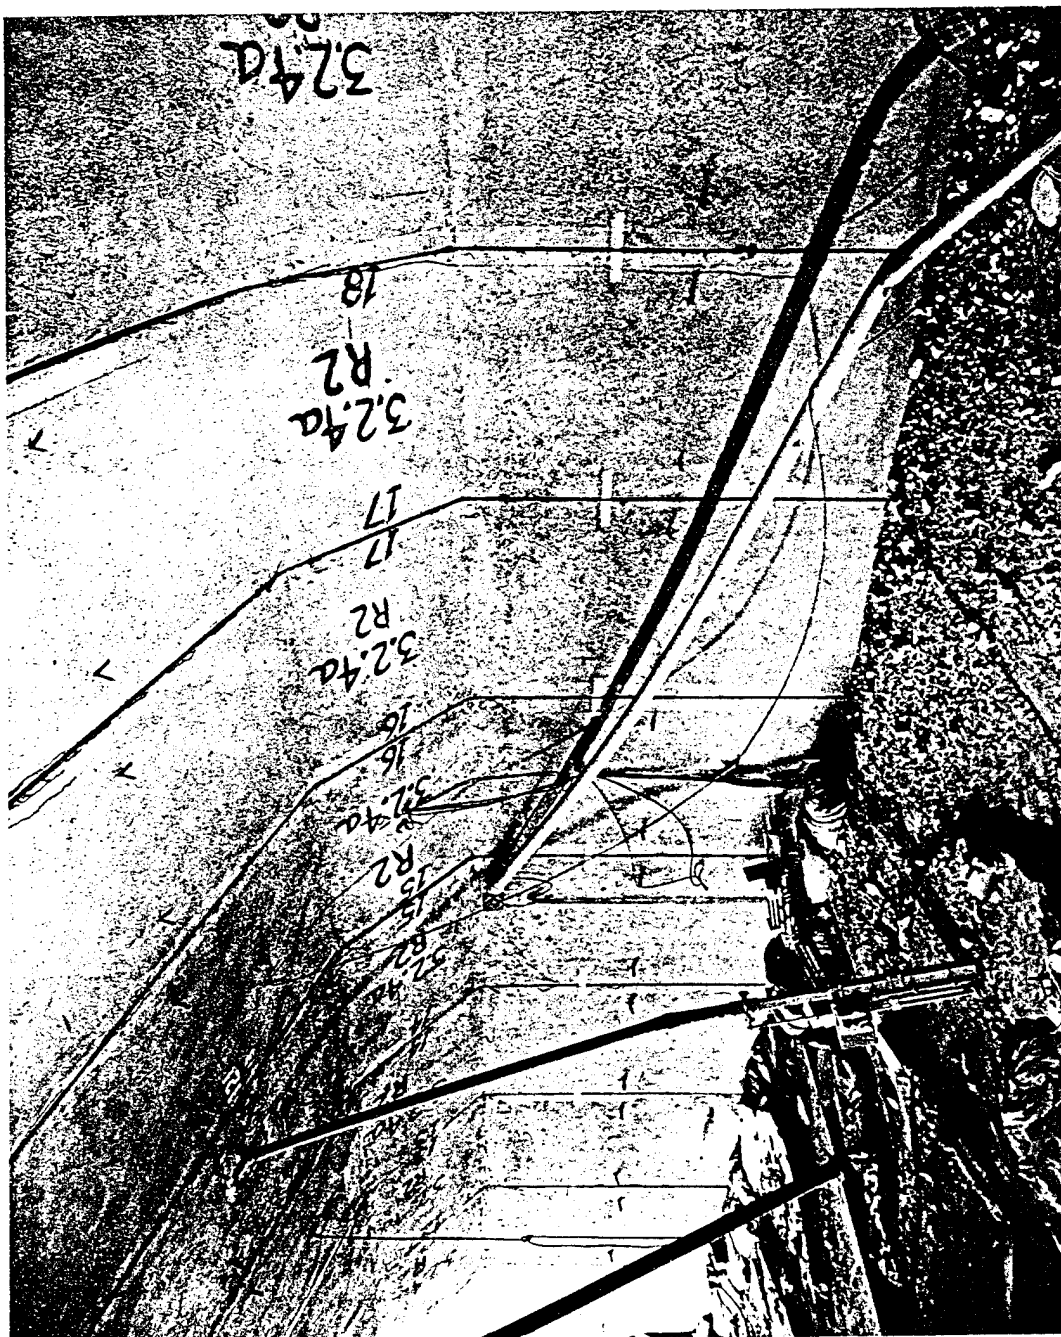
Fig. L. 315 Lower Half of End Panel That Was Adjacent to Front Wall, Structure 3.2.4a. See previous photograph to determine general location. Note the distortion of the $\frac{3}{4}$ -in. steel reinforcing bar that was in the rib of this panel.

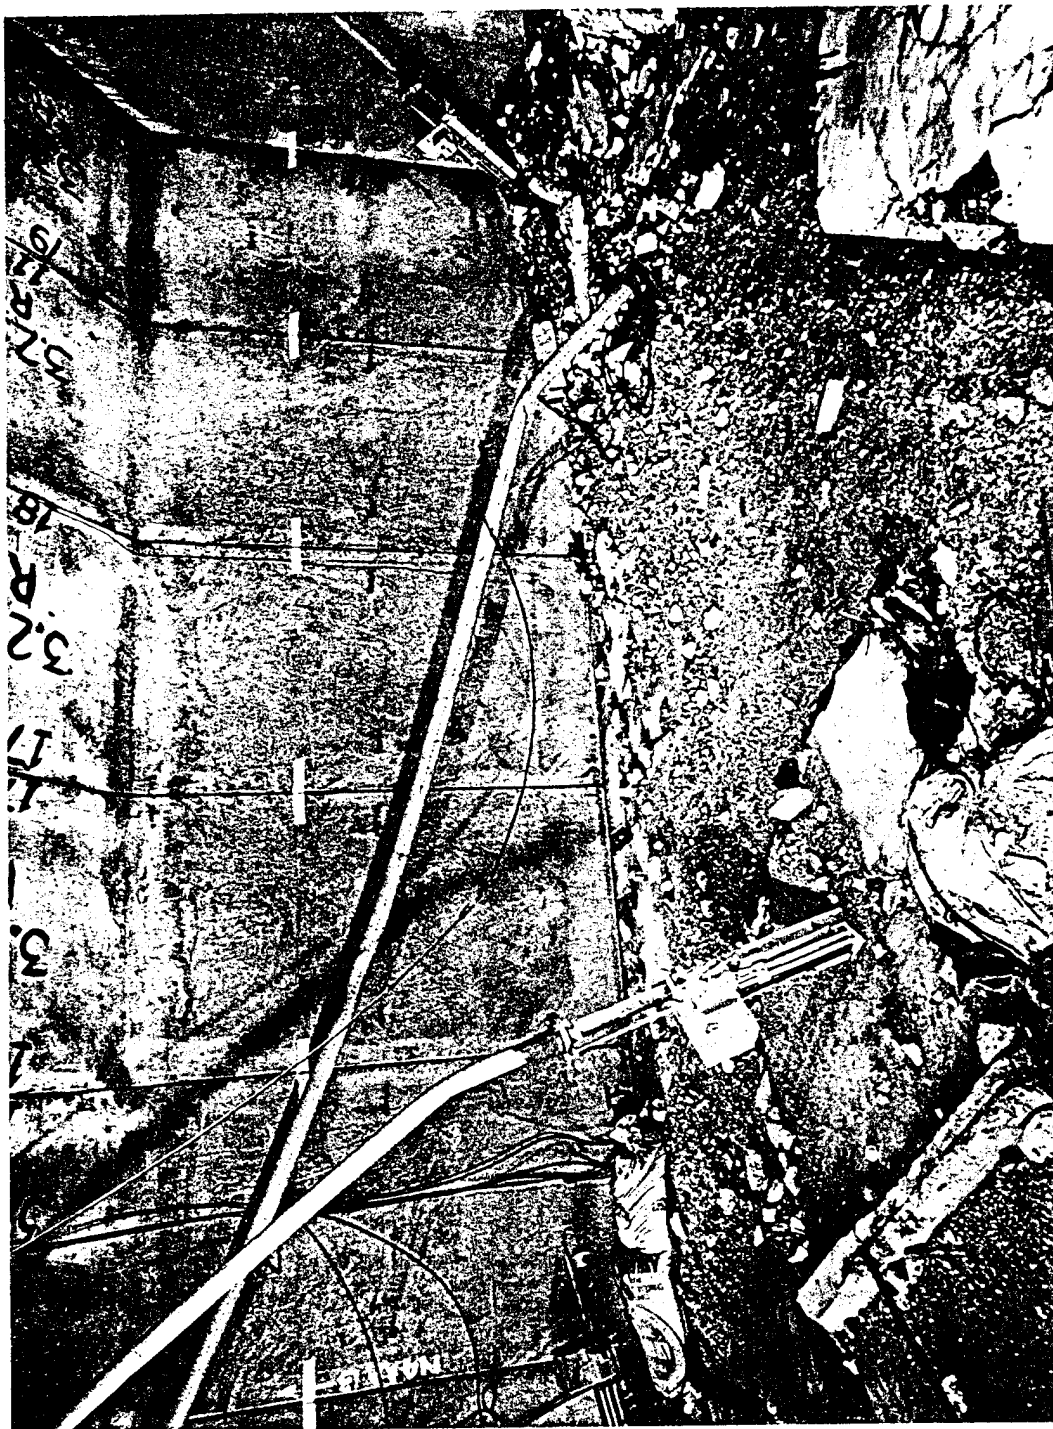
Fig. L. 316 Interior View of Central Portion of Front Wall, Structure 3.2.4a. Open end of structure is to the left of photograph. Note the displacement-gauge rods knocked out of position and bent.

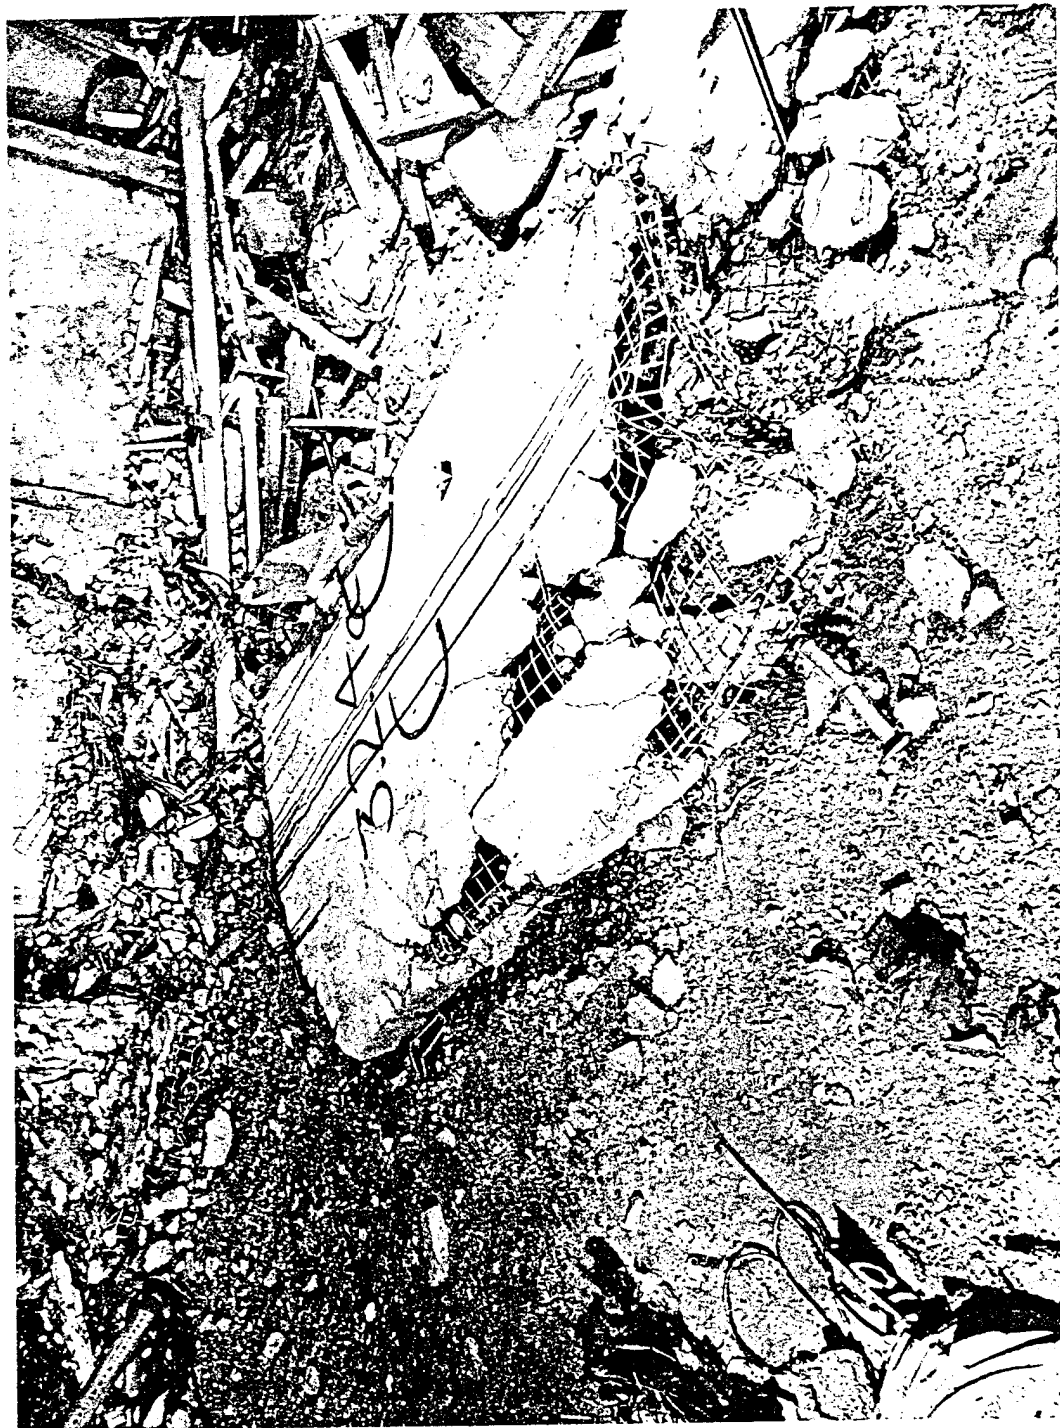
Fig. L.318 View of Left End Wall Adjacent to Front Wall, Structure 3.2.4a. Note the collection of debris at base of wall. Panel in foreground was middle panel (above door) in right end wall. The door panel can be seen lying against the left end wall. Bolts are still in door panel.

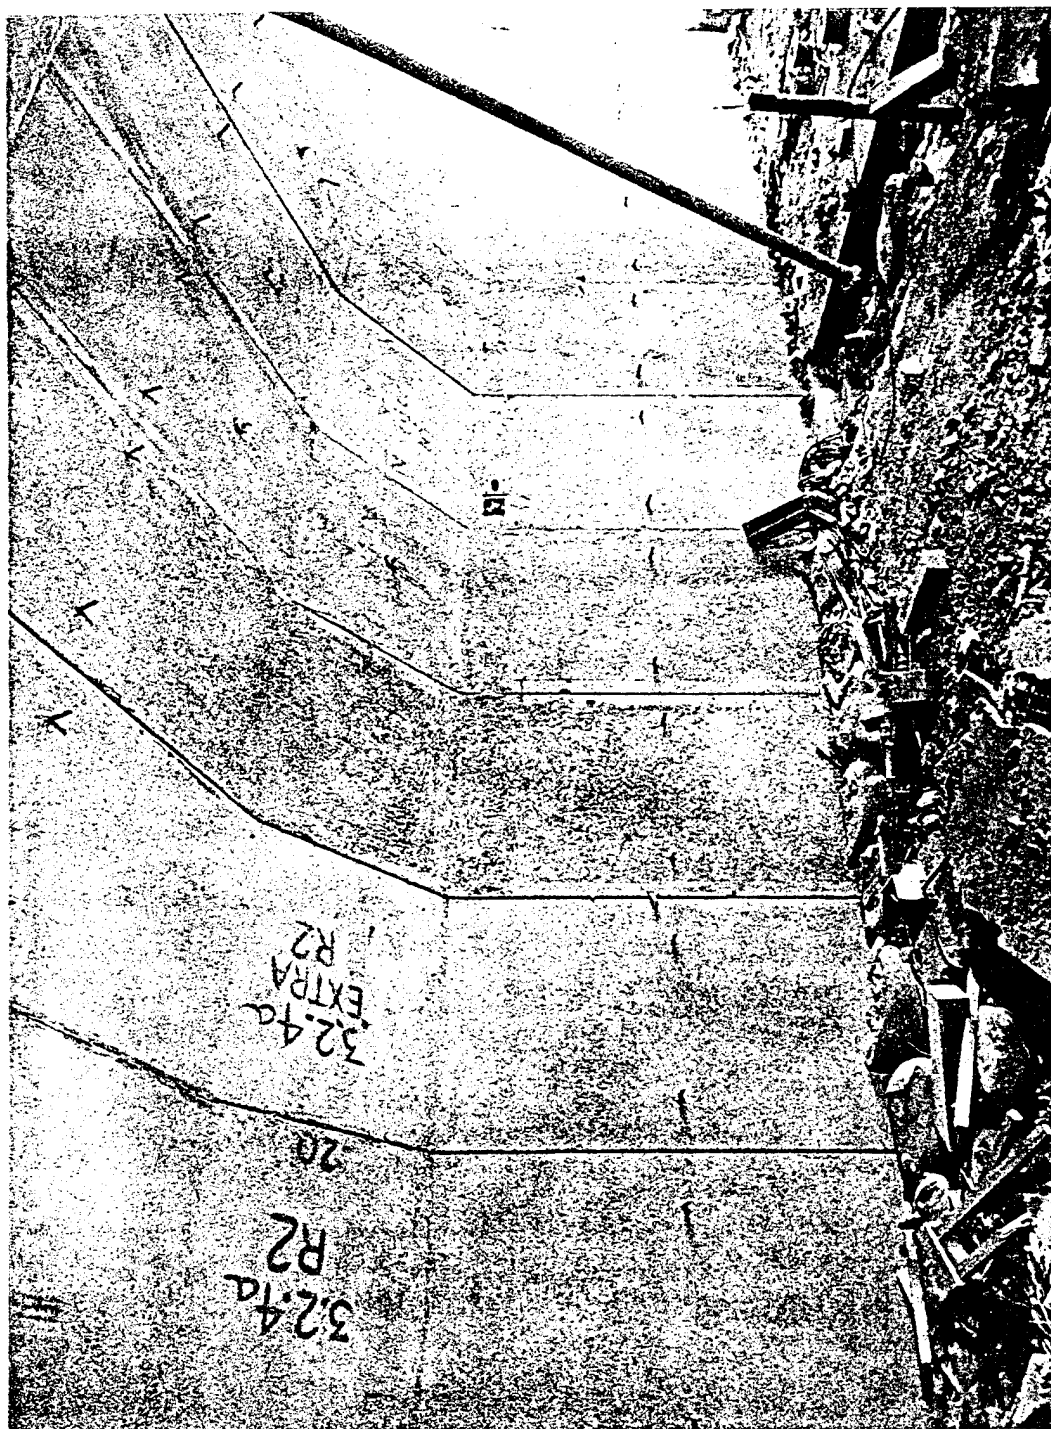
Fig. L. 321 Detail View of Upper Portion of Left End Wall on the Rear Side of Center, Structure 3. 2. 4a. The hole in the end panel was made by a heavy piece of flying debris from the right end wall. Note that steel mesh is still intact in this hole.

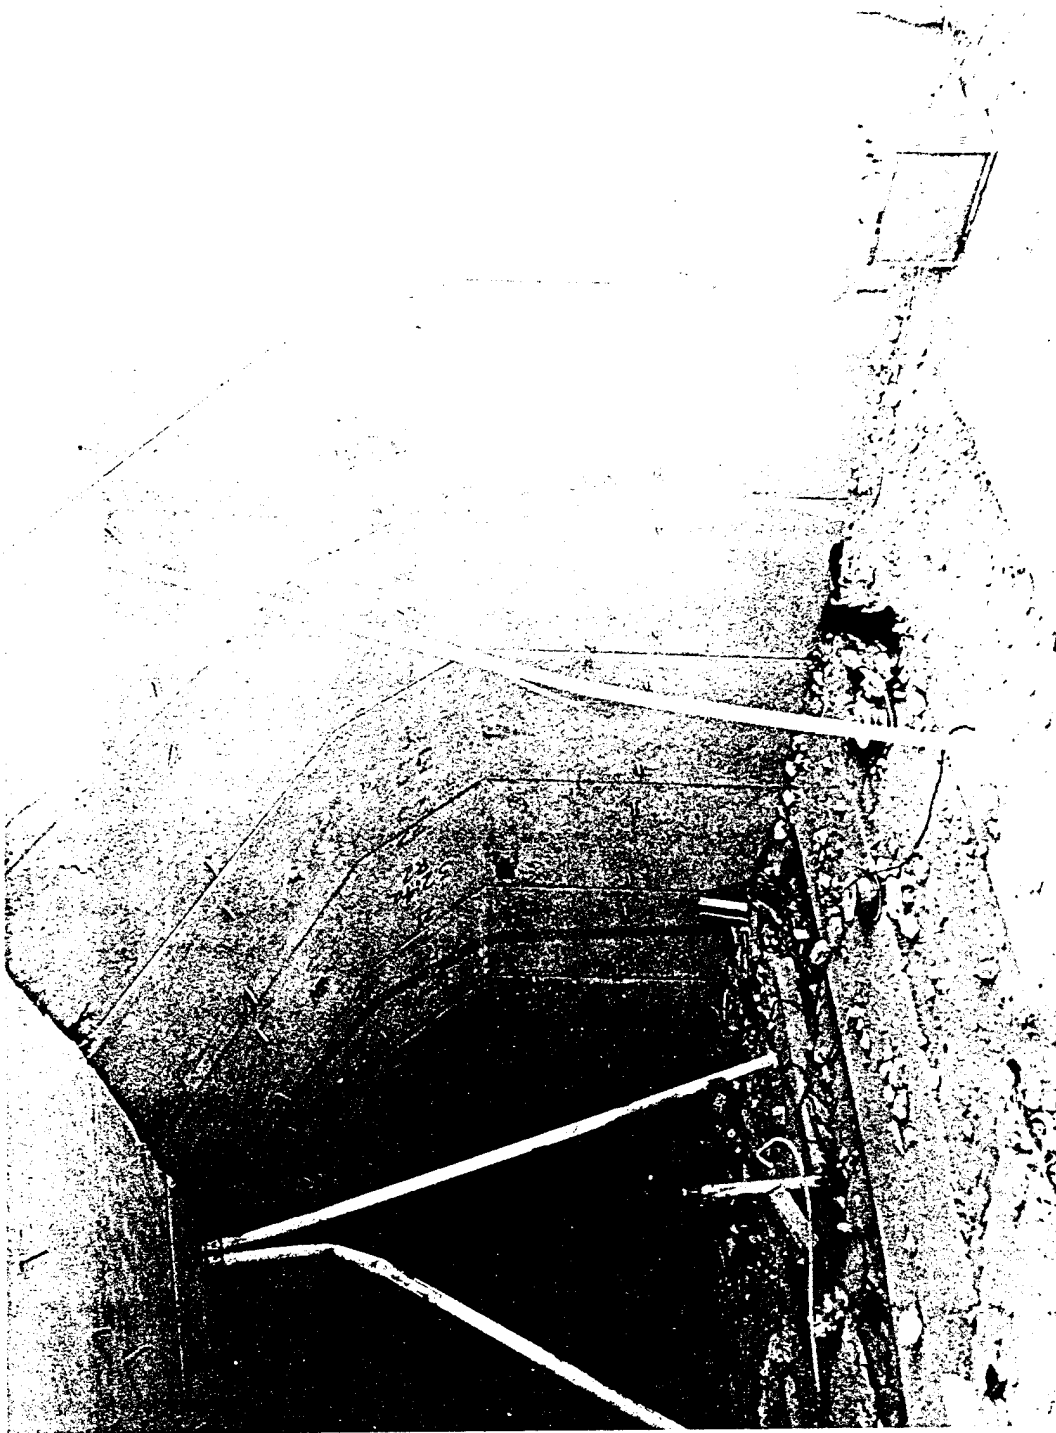
Fig. L. 323 Interior View of Precast Floor, Structure 3.2.4a. The deflection of these panels amounted to about 3 in. at center.

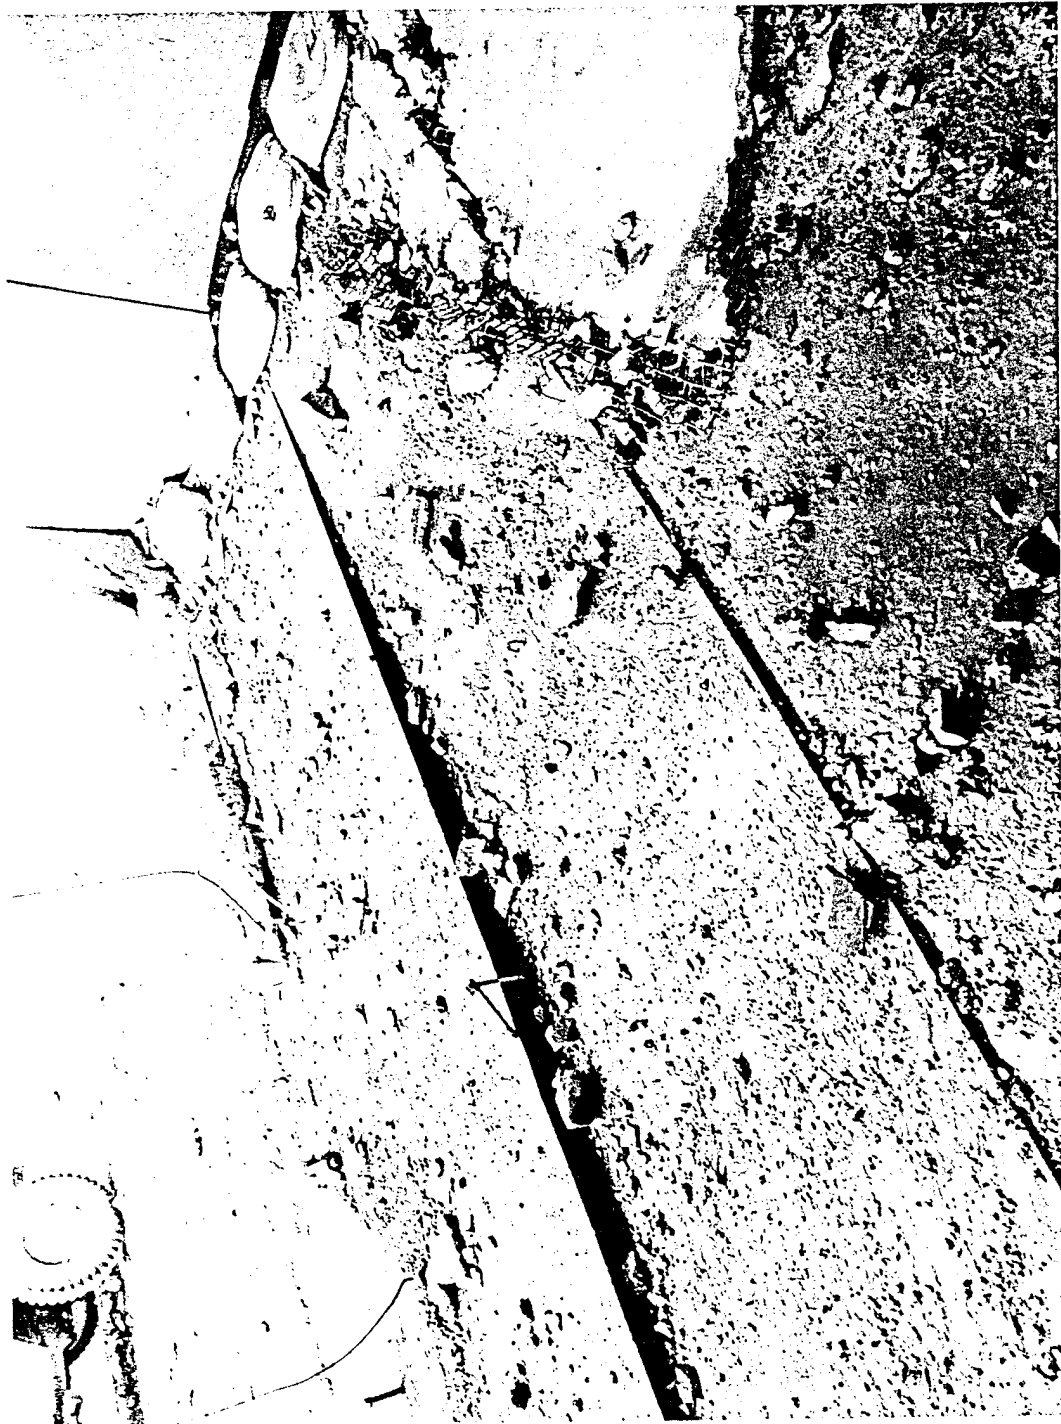
Fig. L. 324 Interior View of Right Half of Rear Wall, Structure 3.2.4a. Steel bars hanging down are from right end-wall panels.

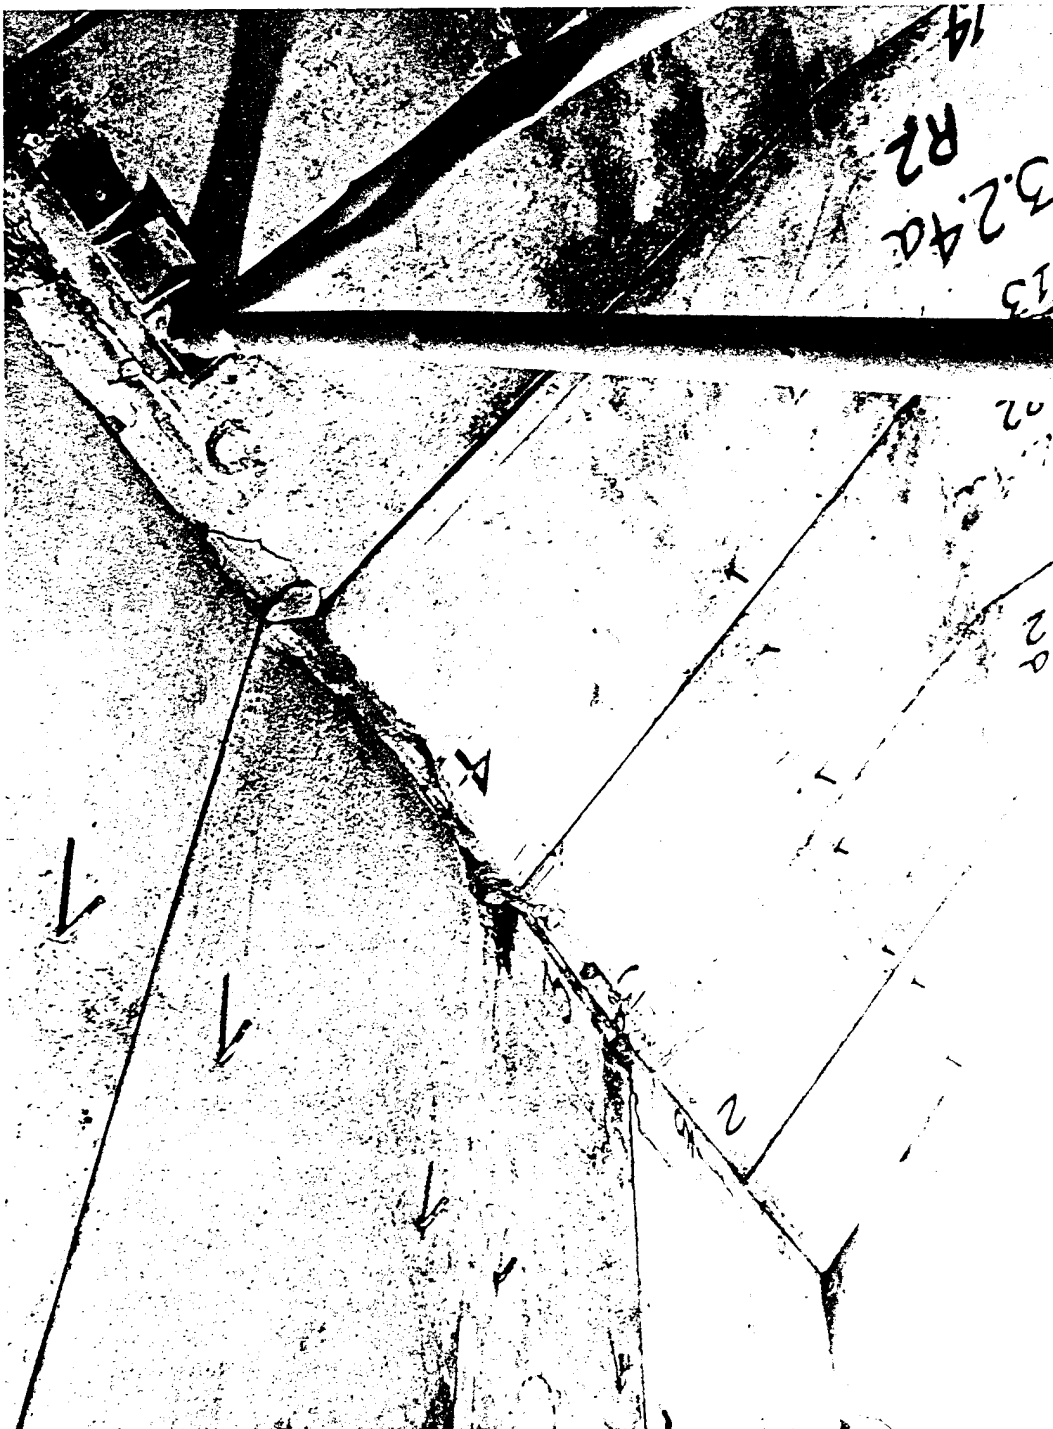
Fig. L. 325 Deflection of Precast Floor Panels, Structure 3.2.4a. Maximum permanent deflection at the center of each panel was about 3 in. End panel had continuous support along one longitudinal edge and did not deflect.

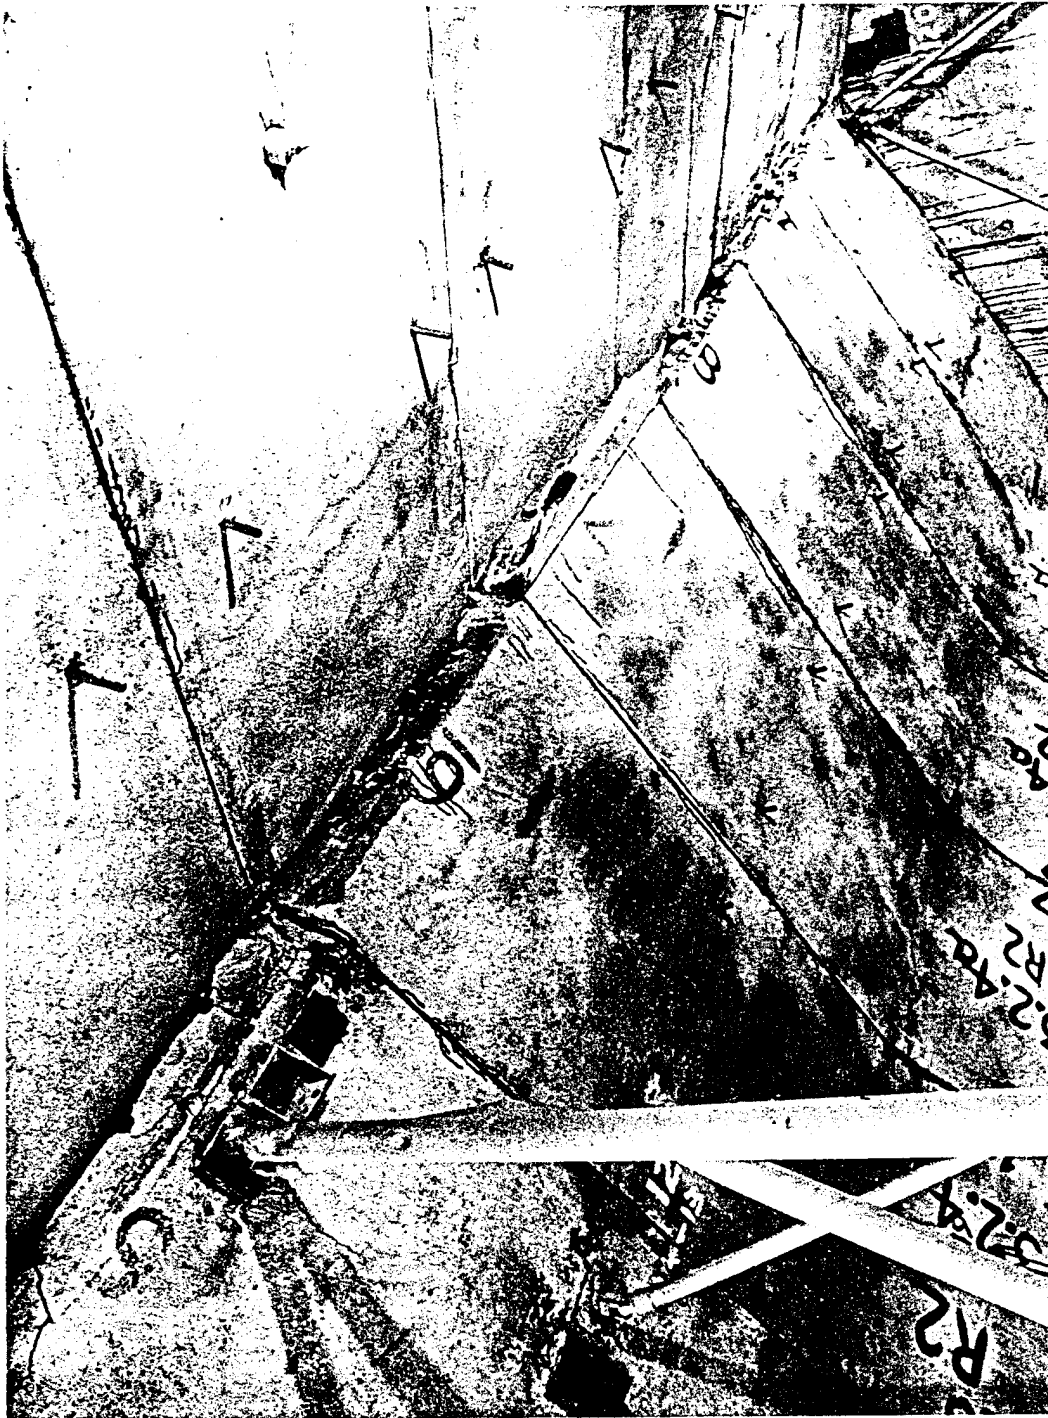
Fig. 'L. 326 Interior View of Right Half of Roof, Structure 3.2.4a. Panels in the center broke at the crown rib and telescoped over each other, but those at the end remained in place.

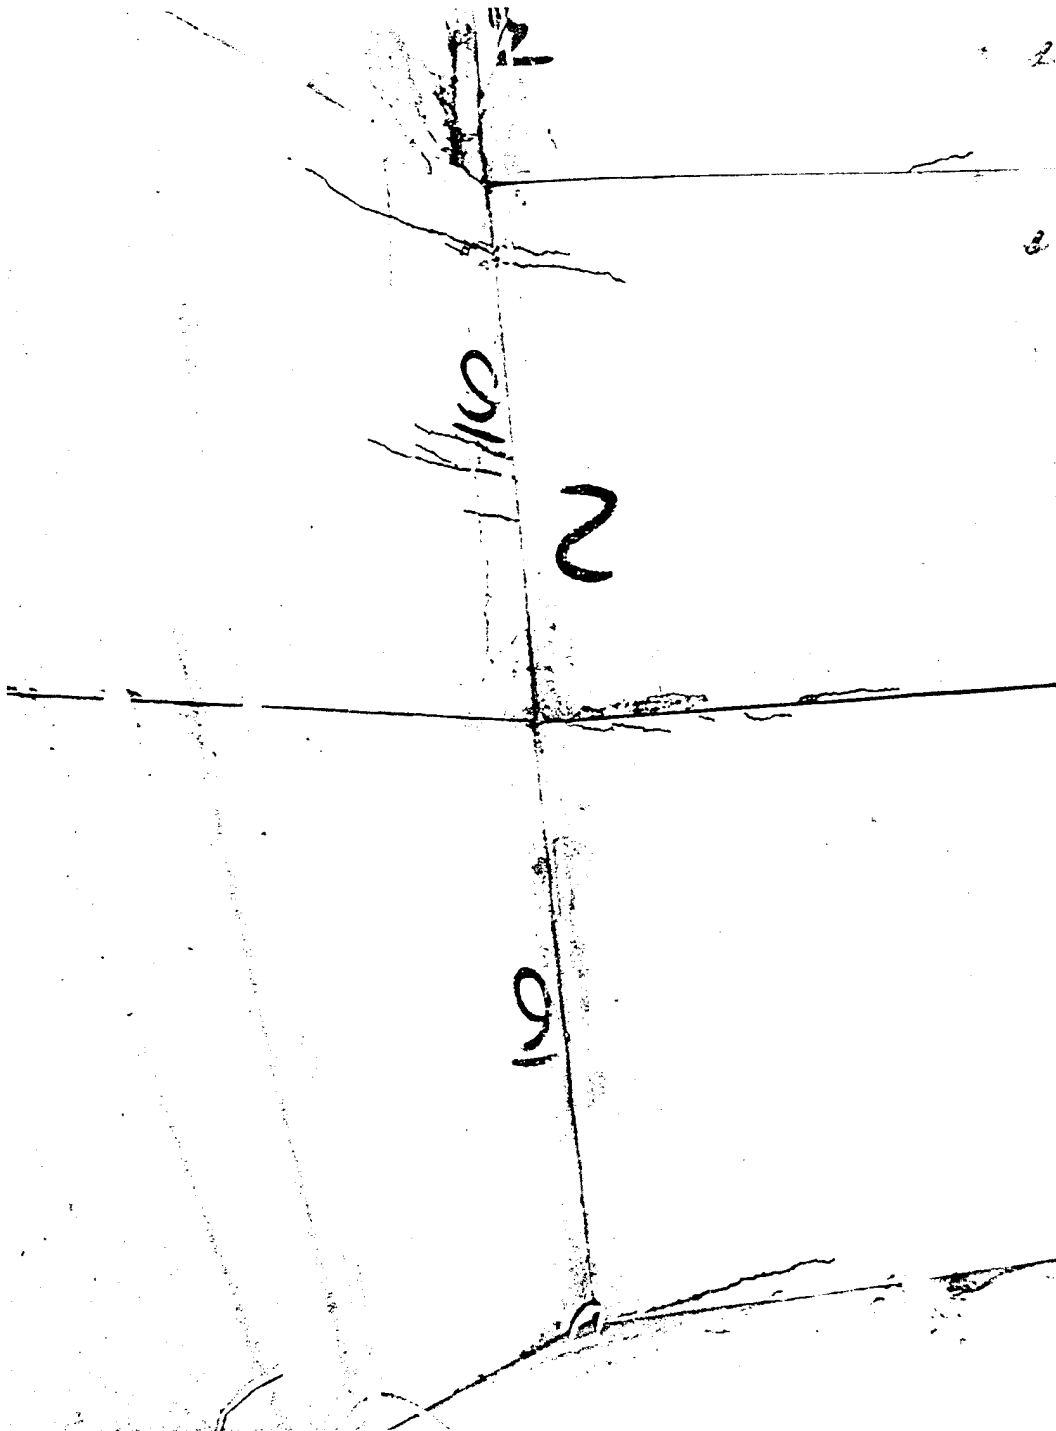
Fig. L. 327 Interior View of Left Half of Roof, Structure 3.2.4a. Panels broke at crown rib and telescoped over each other as much as 8 in. (center panels). Panels at the end suffered cracking of the crown ribs but remained in place.

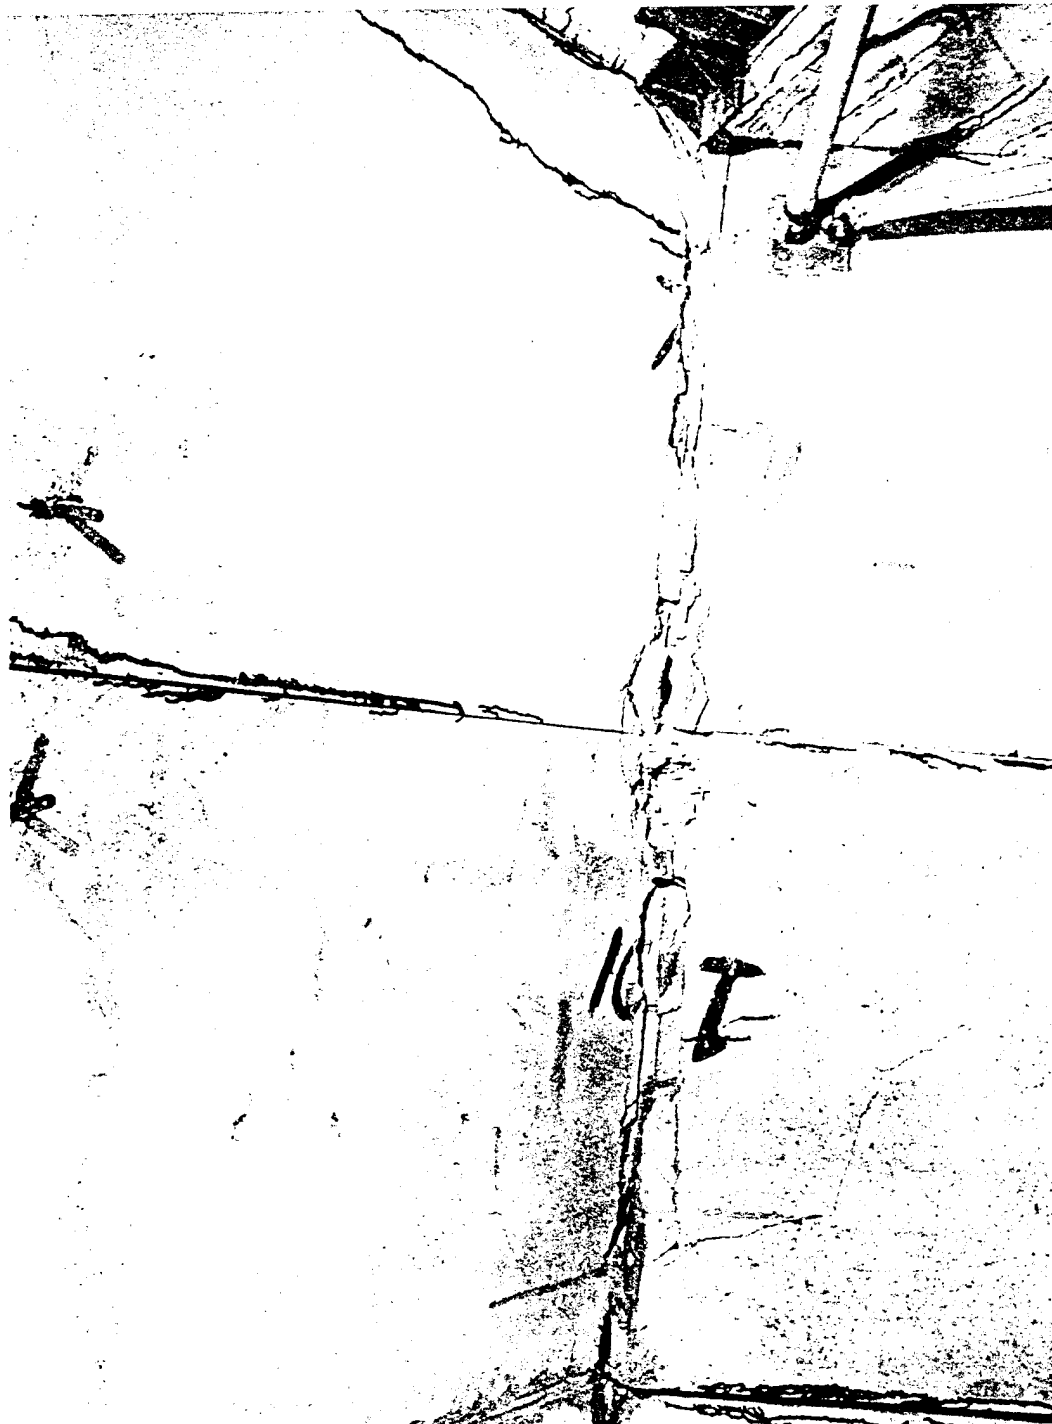
Fig. L. 331 Underside of Crown Rib of Panels 7 and 8, Structure 3.2.4a. Note that the crown rib at panel 7 held, but the rear panel broke just behind this rib.

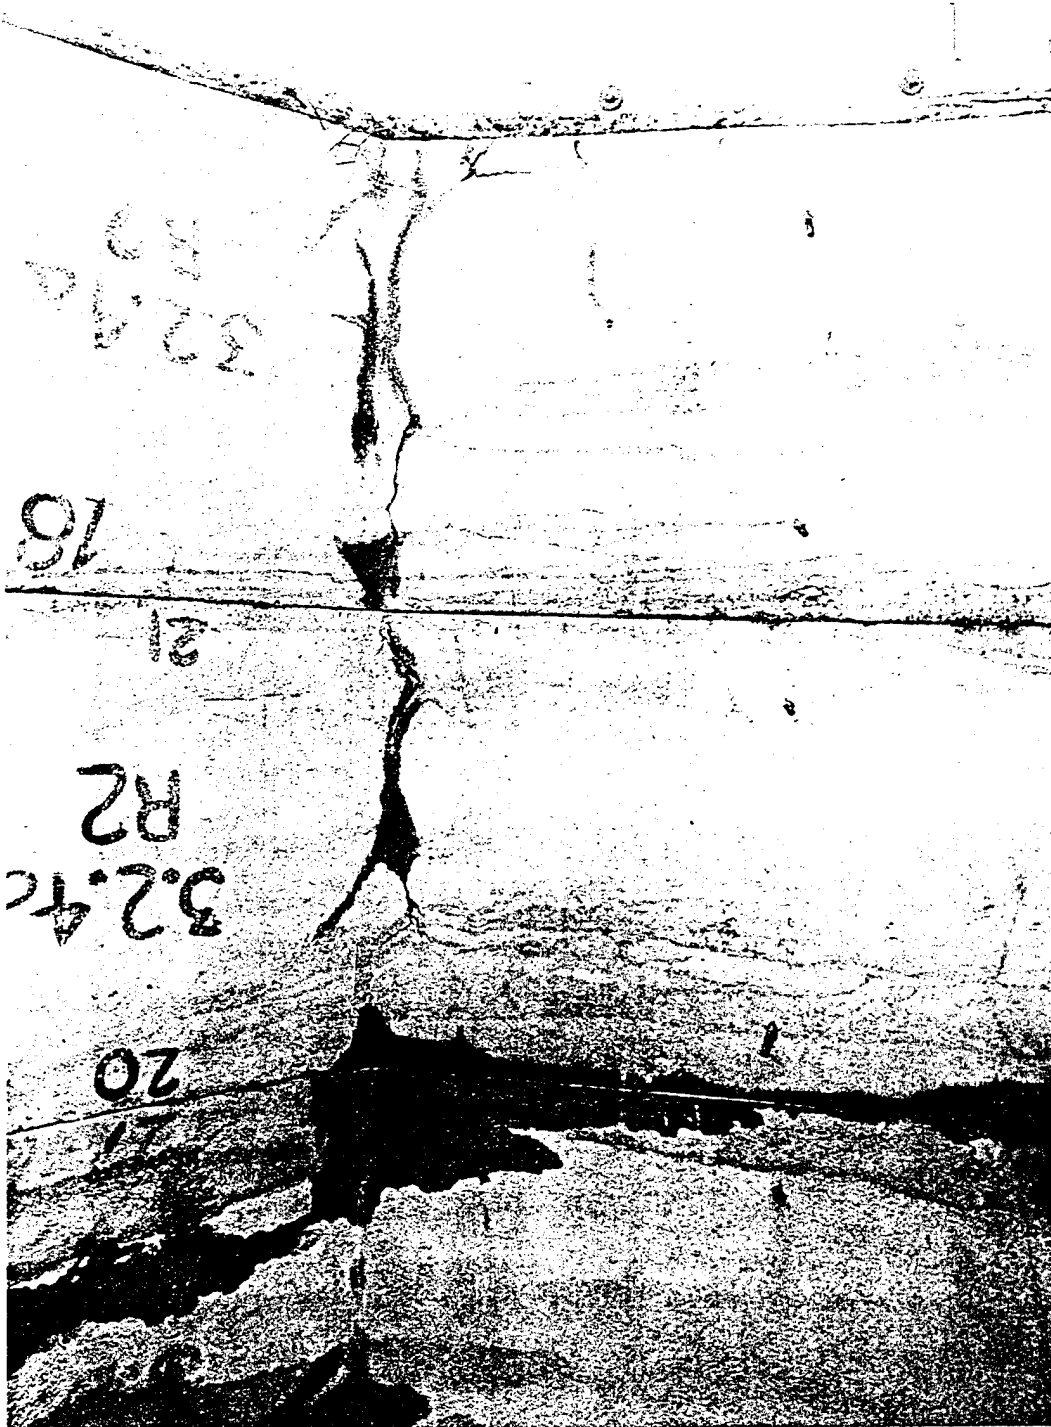
Fig. L. 335 Interior View of Left Half of Rear Wall, Structure 3.2.4a. Tension cracks near base of each panel can be seen.

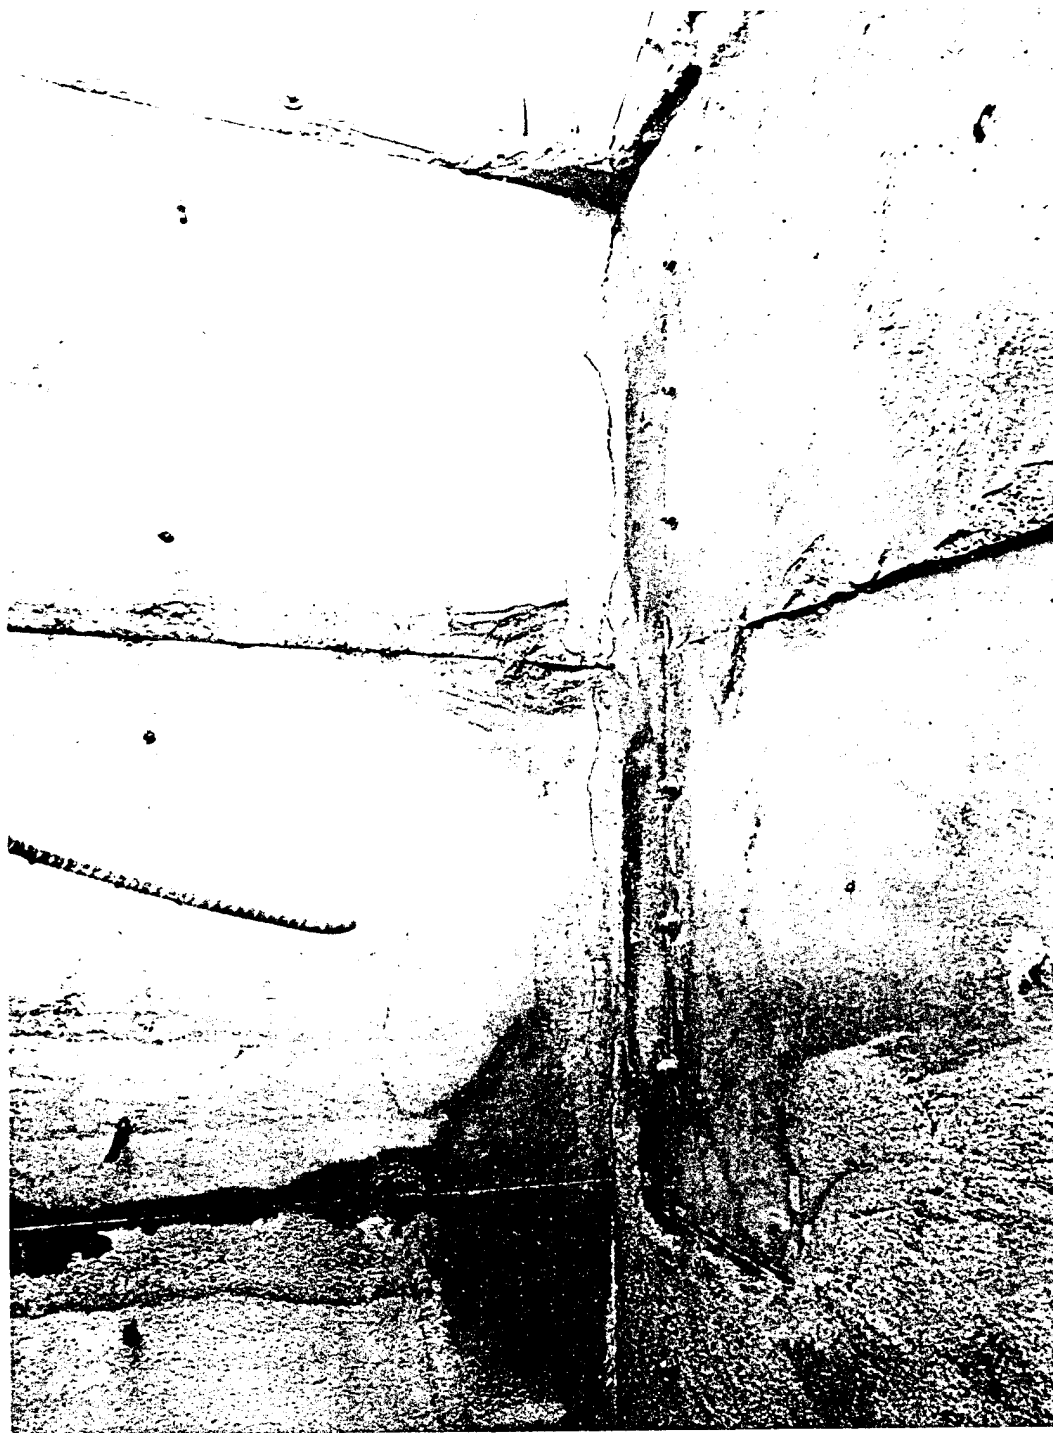
Fig. L. 336 Detail Interior View of Tension Cracks at Lower Fold Point of Rear-wall Panels Adjacent to Right End, Structure 3.2.4a

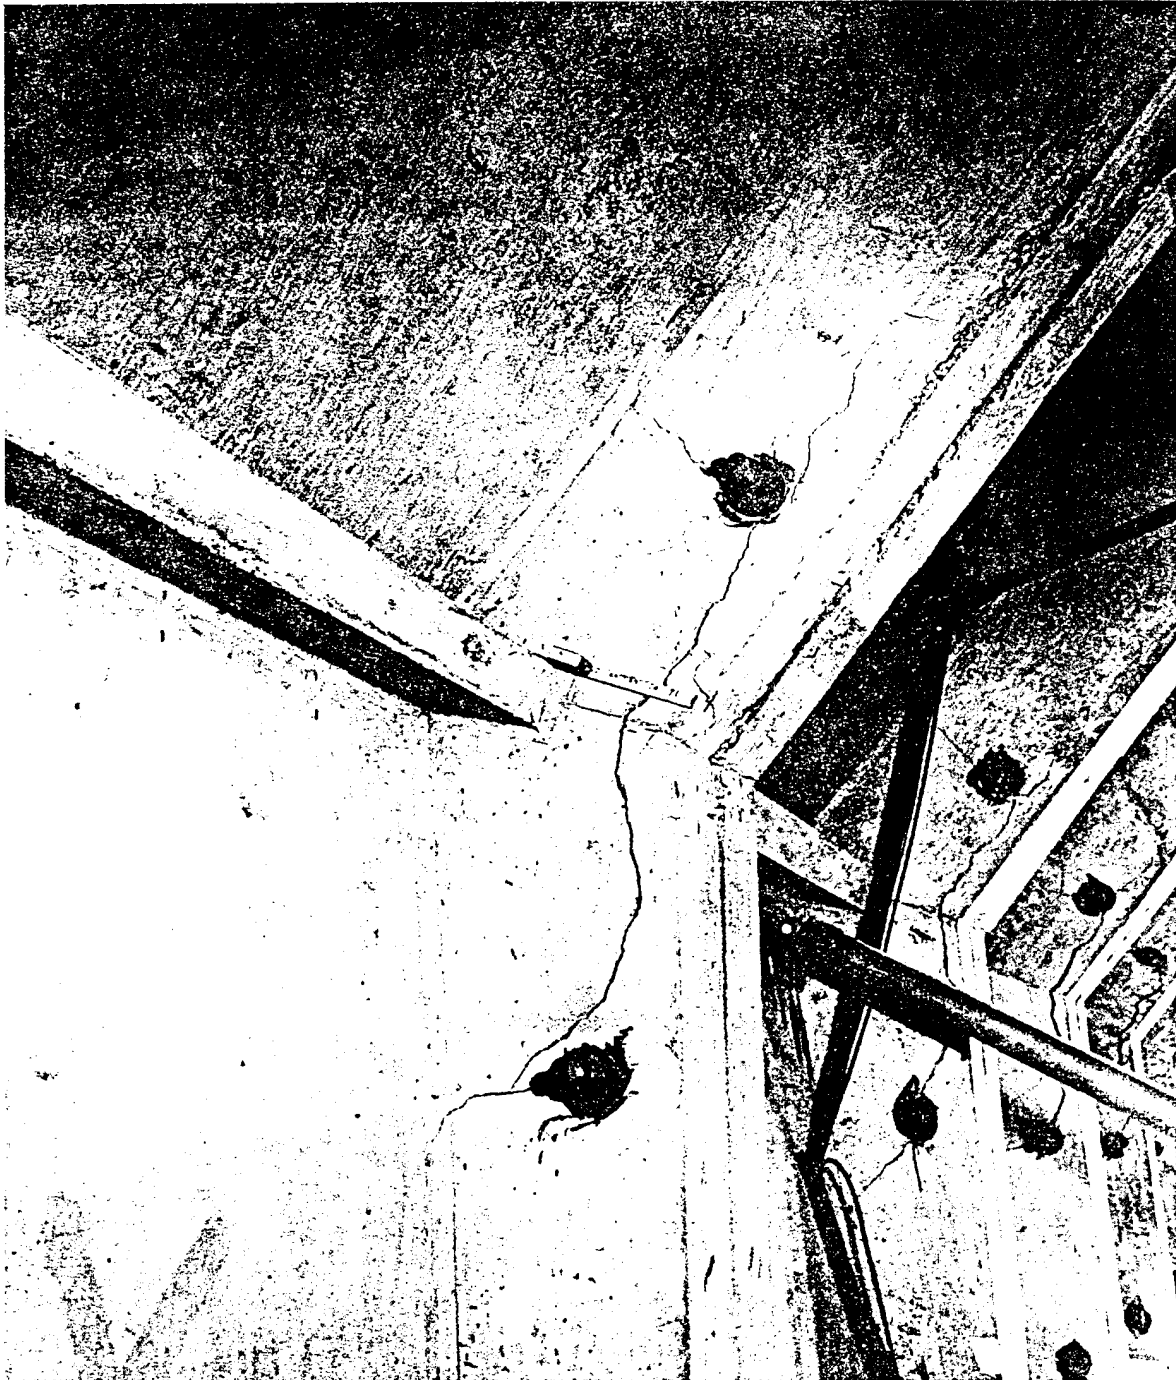
Fig. L.346 Interior View of Left Front Panels Showing Cracks in Rib at Bottom Fold, Taken from Center of Building.
Structure 3.2.4b

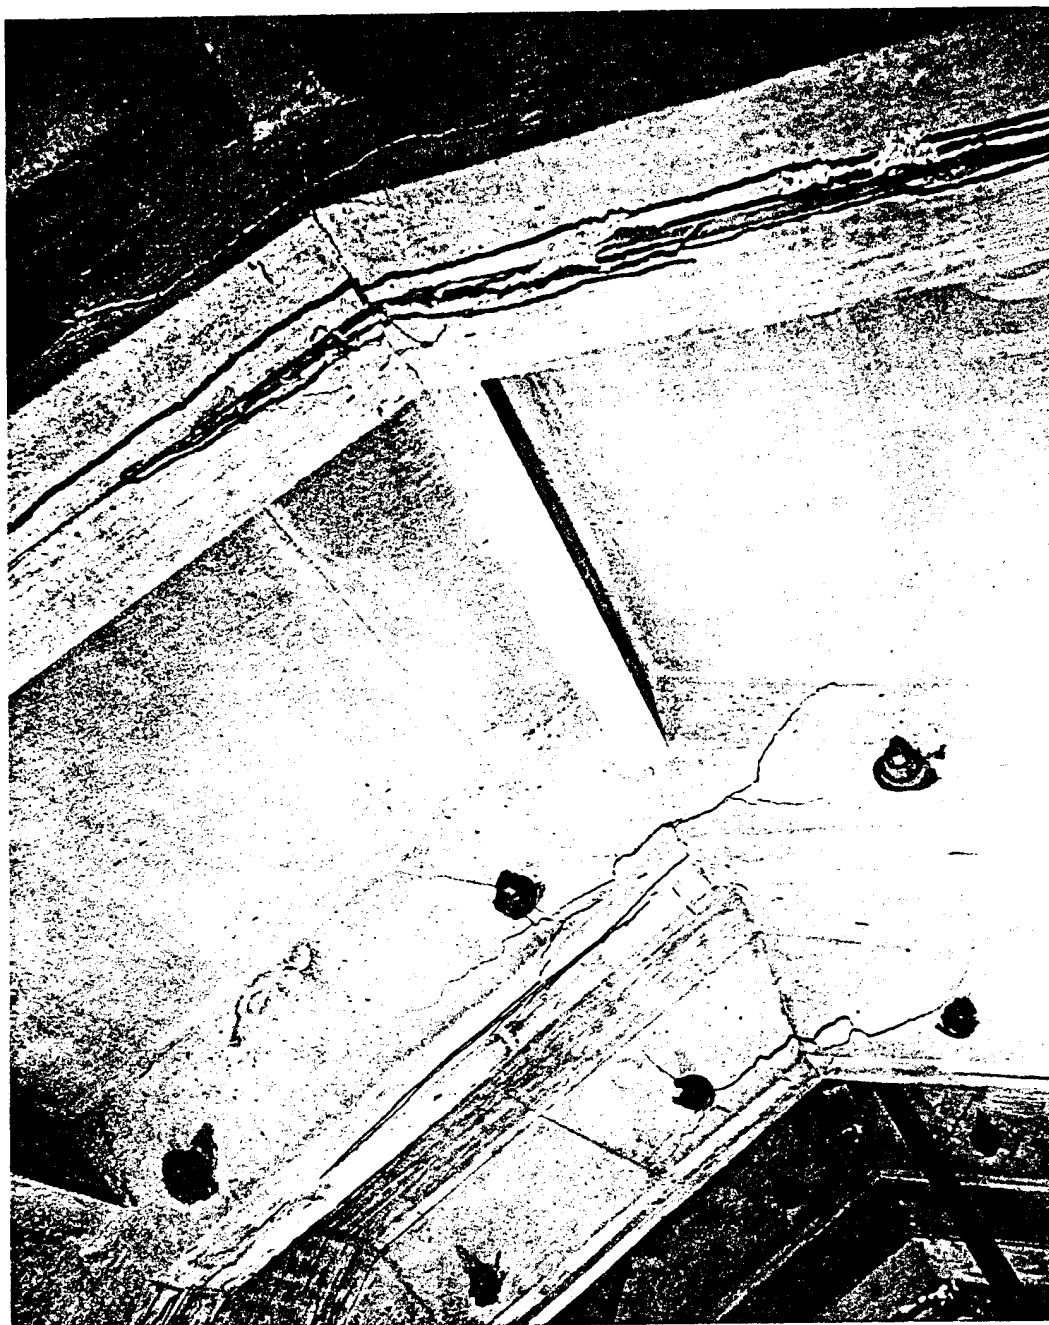
Fig. L. 347 Interior View of Left Front Panels Showing Cracks in Rib at Bottom Fold, Taken from Left End of Building, Structure 3.2.4b
